PRELIMINARY REPORT

HIGHWAY

HWY15MH009

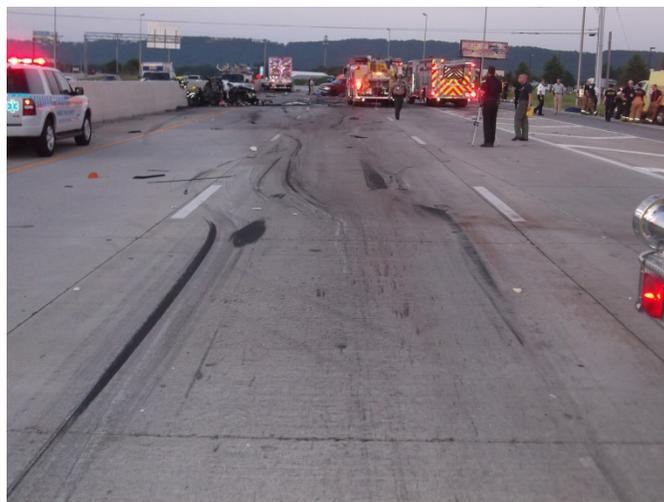
Figure 1. Tire marks following initial impact event and leading to subsequent impacts (Source – Chattanooga DOT).

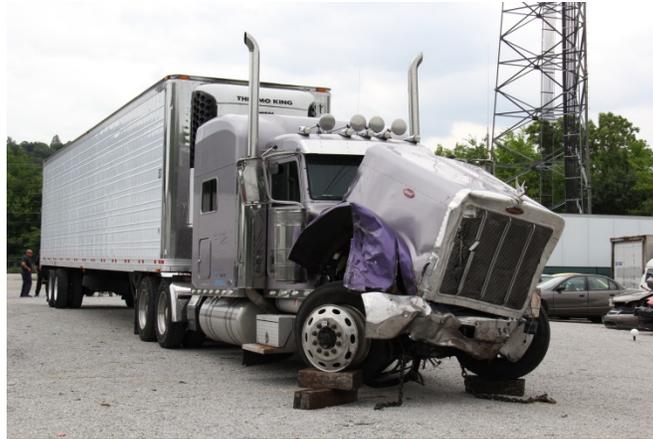
Figure 2. Postcrash damage to the 2007 Peterbilt truck-tractor.
